Appendix E

Photograph Log

Controlling Runoff from New Development, Redevelopment and Construction Sites

Inspection Dates: July 15–16, 2013

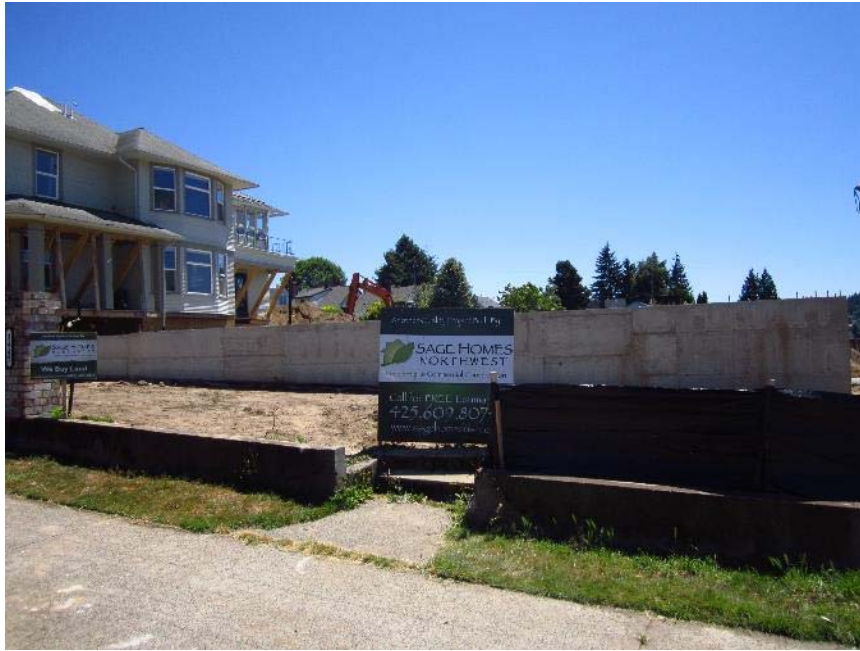
Photograph 1. Sage Homes Northwest– View facing south of construction site.

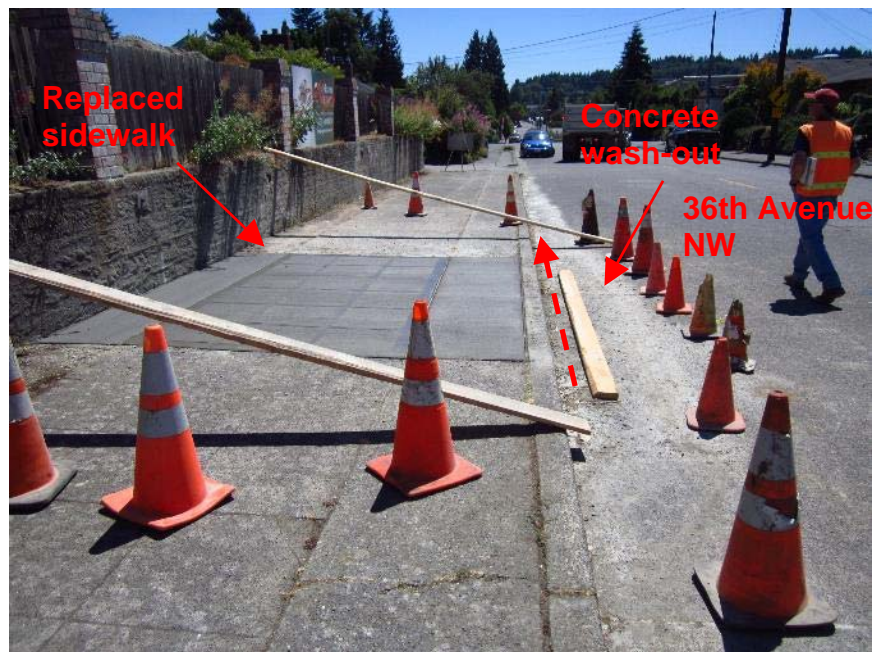
Photograph 2. Sage Homes Northwest – View facing south of concrete wash-out generated while replacing a section of the sidewalk as part of the project.

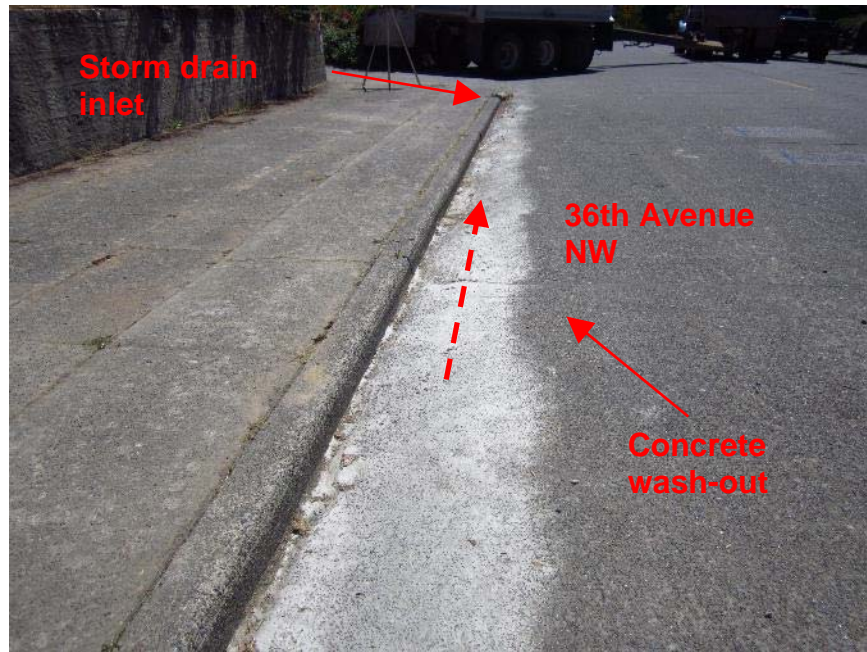
Photograph 3. Sage Homes Northwest – View of concrete wash-out from construction site flowing south to a storm drain inlet.

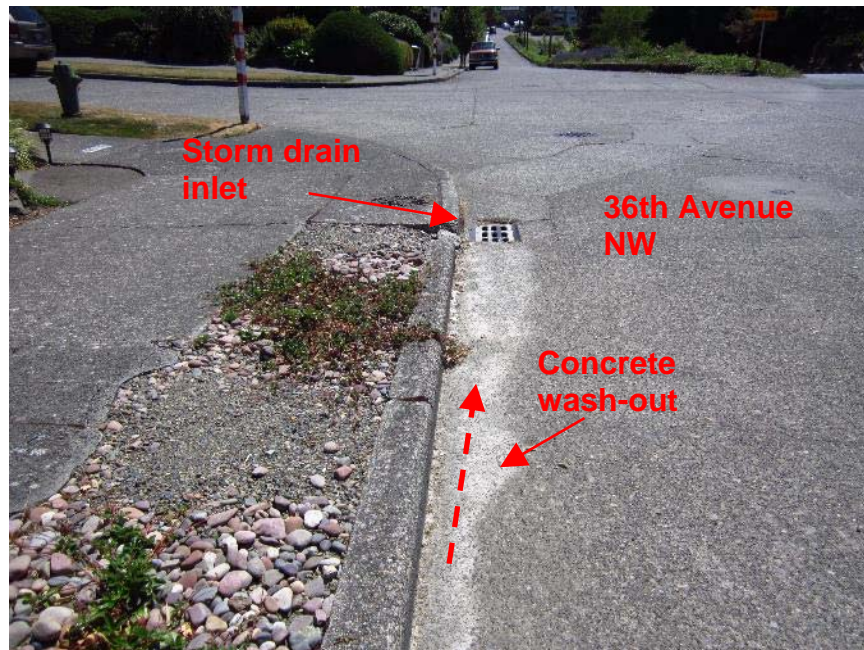
Photograph 4. Sage Homes Northwest –View of concrete wash-out trailing south to a storm drain inlet downgradient of the construction area as shown in Photograph 1.

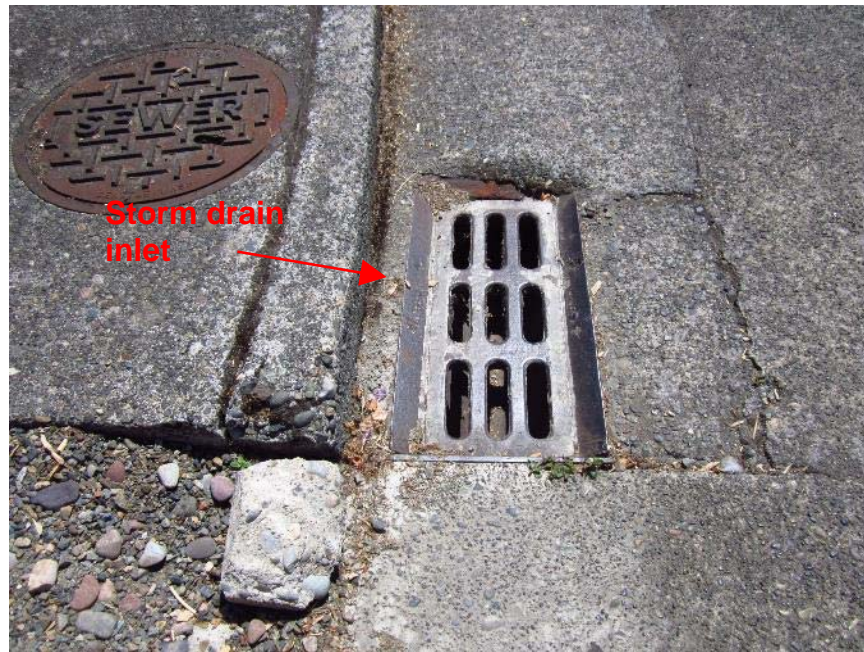
Photograph 5. Sage Homes Northwest – Closeup view of concrete wash-out (as shown in Photographs 3 and 4) trailing to a storm drain inlet and evidence of discharge to the City's MS4.

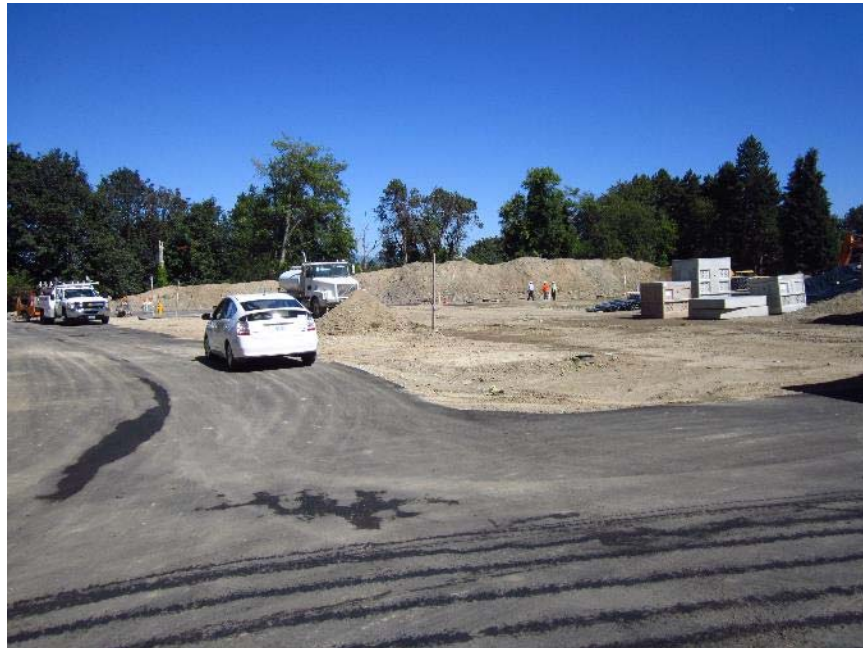
Photograph 6. High Point Development – View facing east of the High Point Development site.

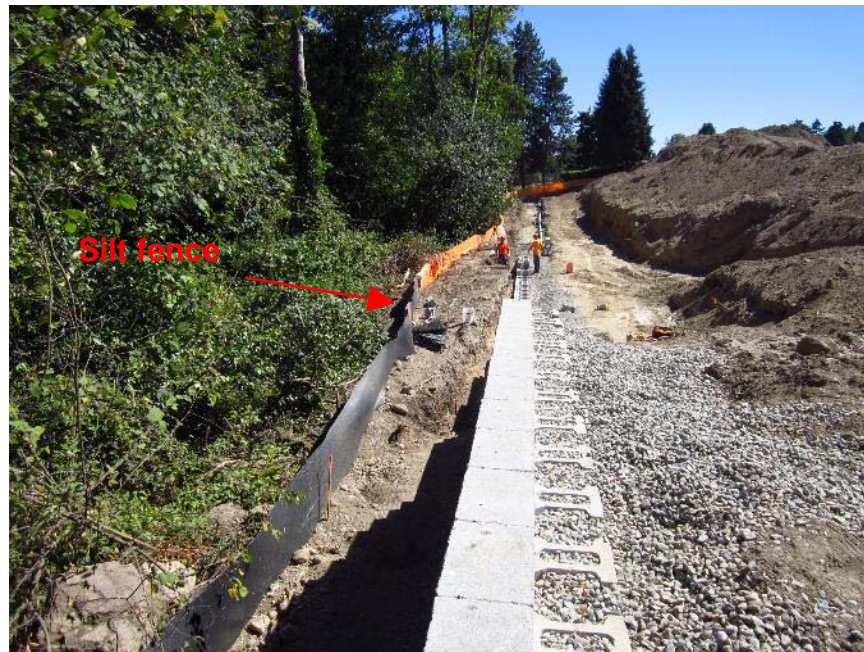
Photograph 7. High Point Development – View facing south of silt fence around the eastern perimeter of construction site.

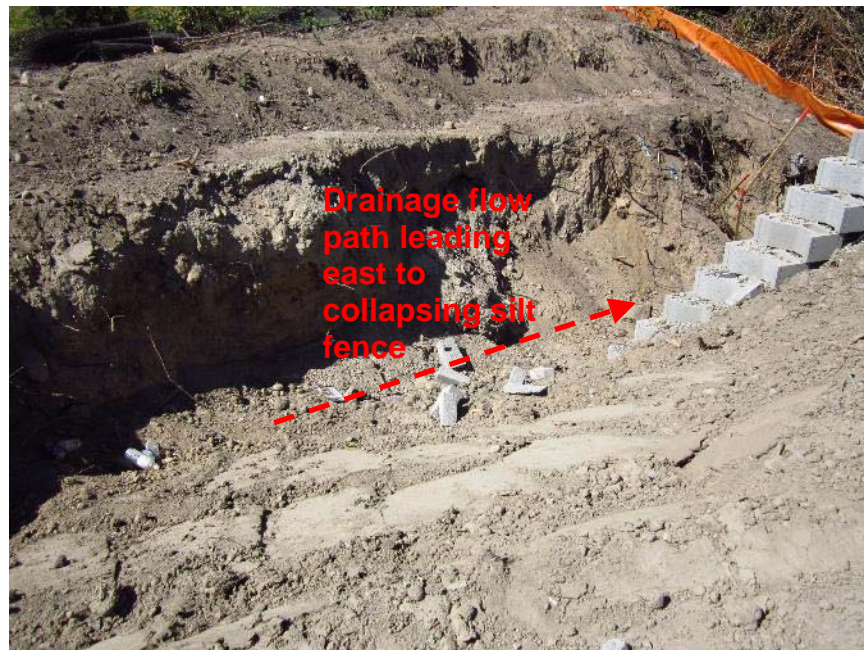
Photograph 8. High Point Development – View facing northeast of disturbed soil in the northeast corner of the construction site. Note that the soil formed a conduit that could direct runoff east around the side of the newly constructed wall and to the collapsing silt fence shown in Photograph 7.

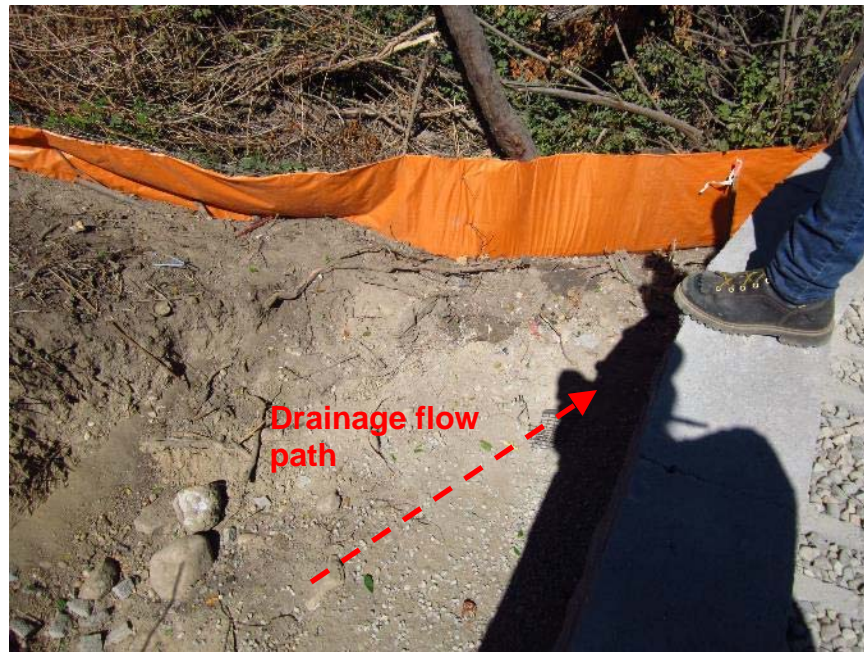
Photograph 9. High Point Development – View facing east of the soil conduit leading southeast around the wall to the collapsing silt fence shown in Photograph 7.

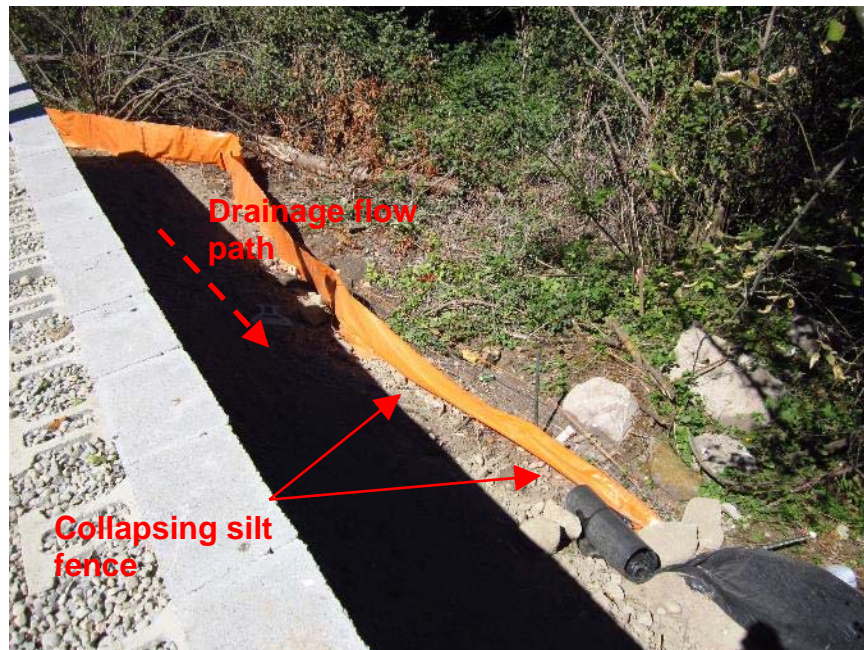
Photograph 10. High Point Development – View facing northeast of collapsing silt fence in the northeast corner of the construction site. Note that water flowing down from around the corner of a newly constructed wall would be directed east at the collapsing silt fence.

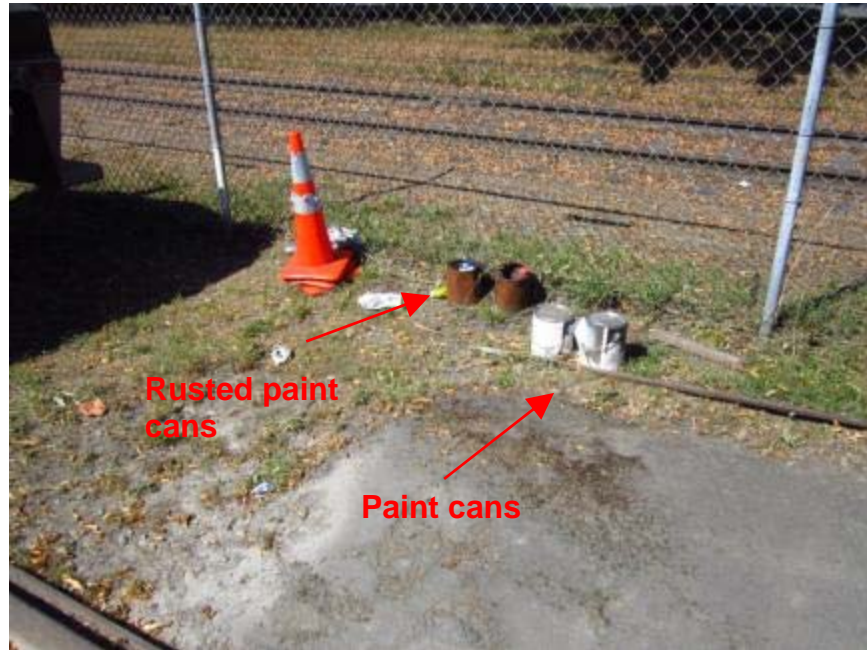
Photograph 11. Sunny Jim Maintenance Yard – View facing west of two rusted paint cans and two additional paint cans containing road paint.

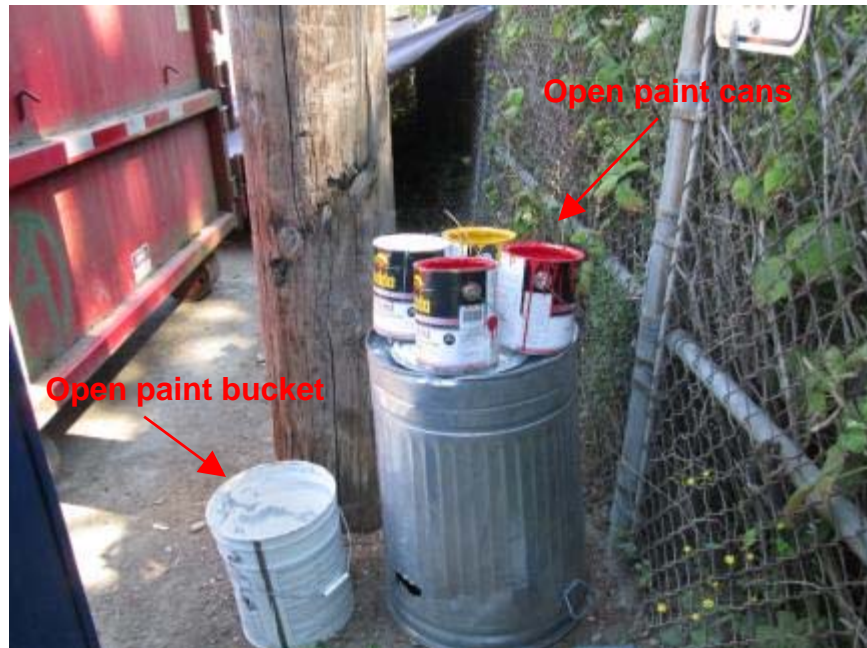
Photograph 12. Sunny Jim Maintenance Yard – View of open paint cans and paint bucket stored behind dumpsters in the southeast area of the property.

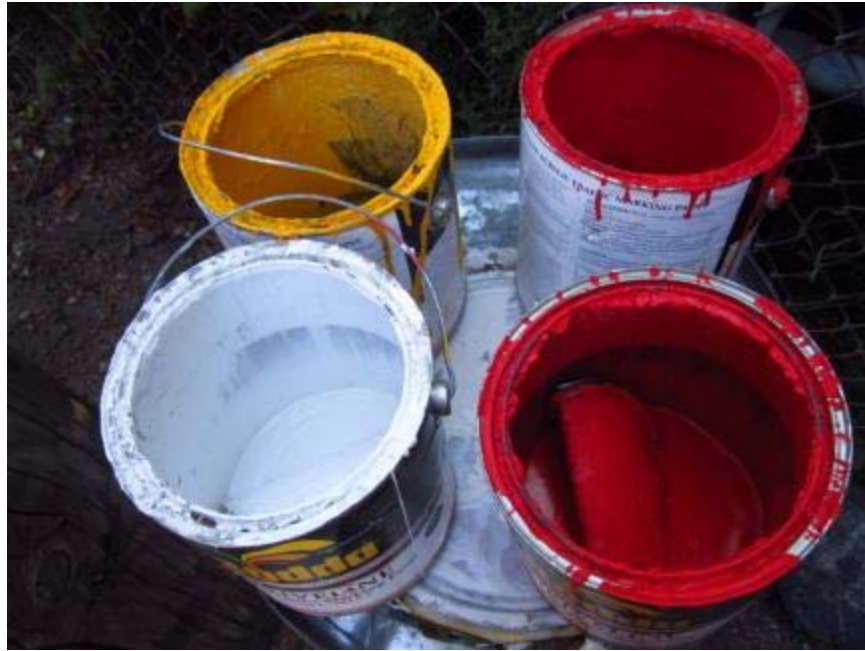
Photograph 13. Sunny Jim Maintenance Yard – Closeup view of open paint cans depicted in Photograph 12.

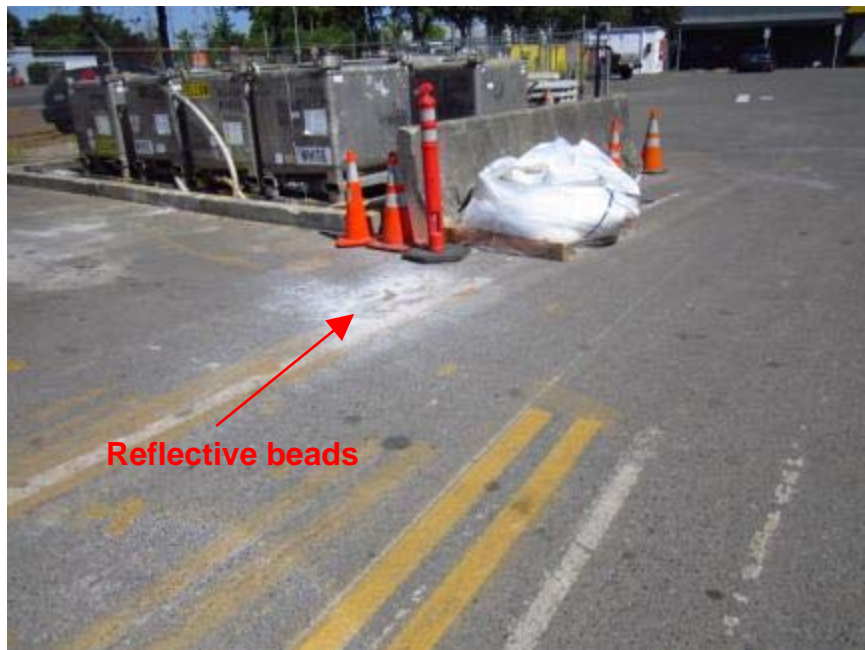
Photograph 14. Sunny Jim Maintenance Yard – View facing northwest of reflective beads spilled on the pavement in the central area of the property.

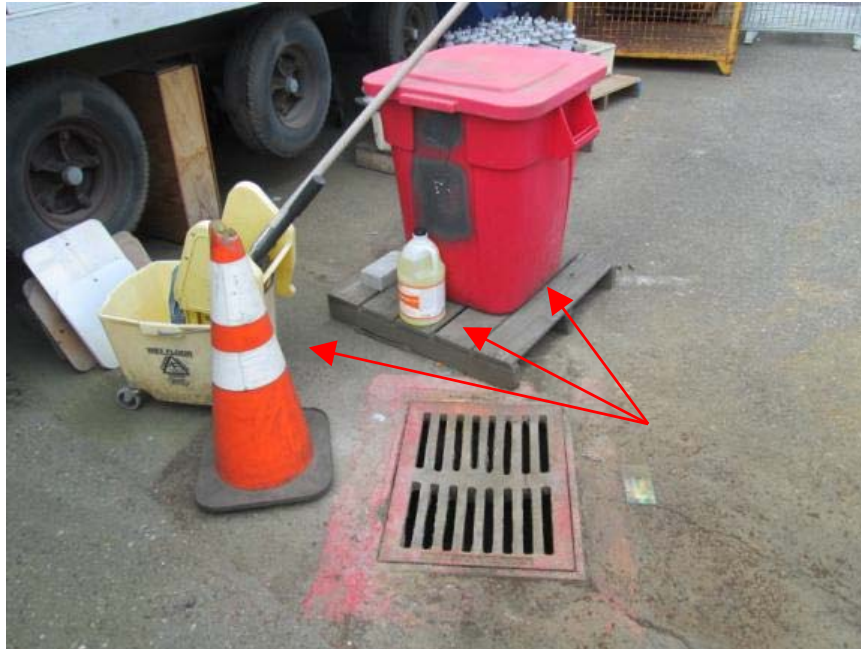
Photograph 15. Seattle City Light South Service Center – View of mop, bucket, soap/detergent, and wastewater stored in close vicinity to a storm drain inlet in the northwest portion of the materials storage yard. Note the red paint around the storm drain indicated that the inlet flows to the stormsewer.

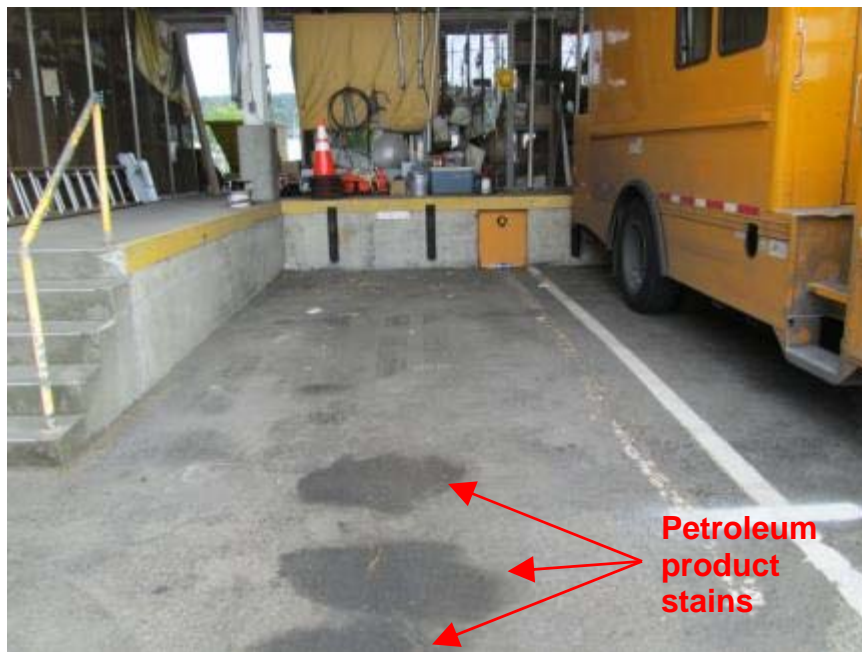
Photograph 16. Seattle City Light South Service Center – View of petroleum product stains on the pavement located in bays at the loading dock and vehicle storage area in the eastern part of the property.

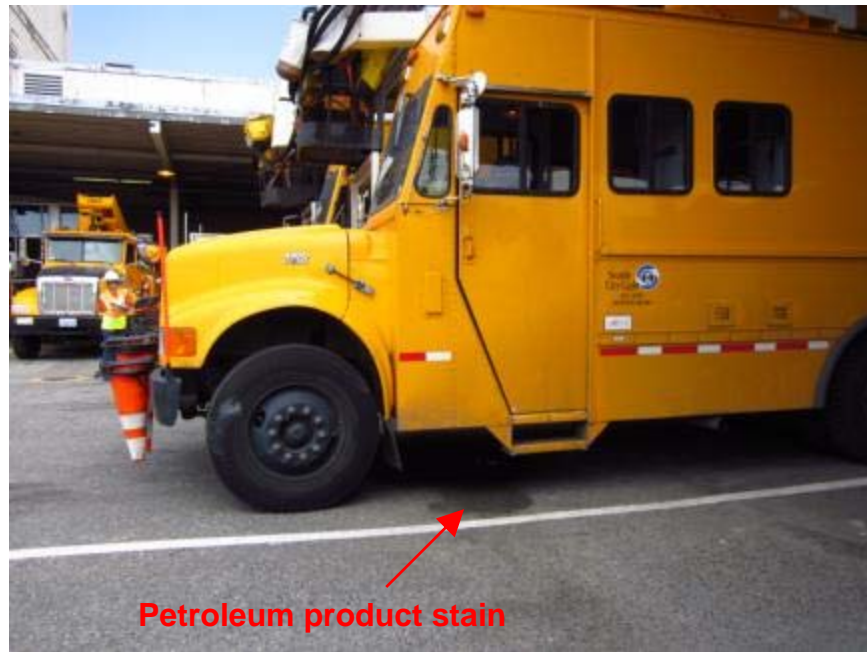
Photograph 17: Seattle City Light South Service Center – View facing northeast of petroleum product stain on pavement under a truck in the loading dock of the vehicle storage area of the property.

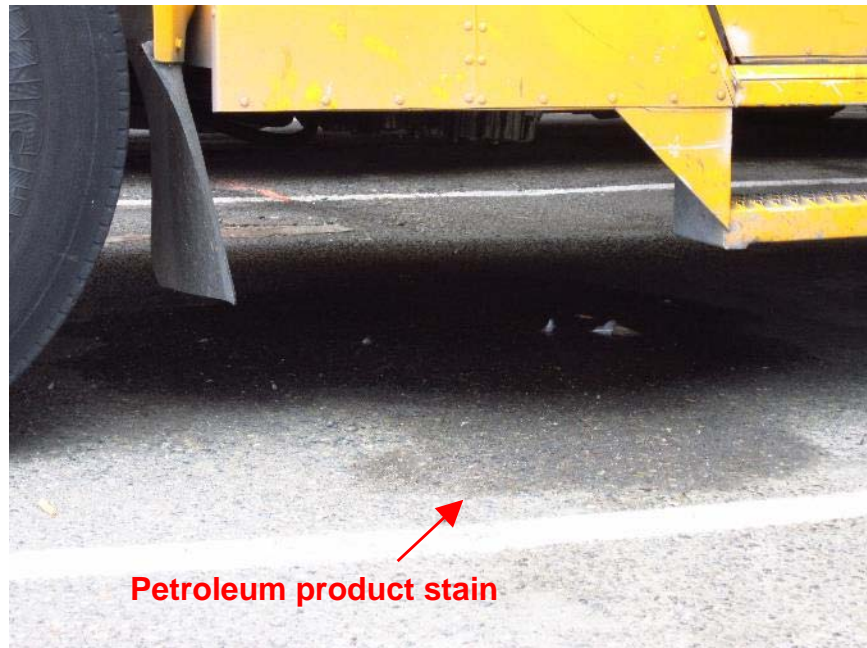
Photograph 18: Seattle City Light South Service Center – Closeup view of petroleum product stain on pavement under truck as depicted in Photograph 17.

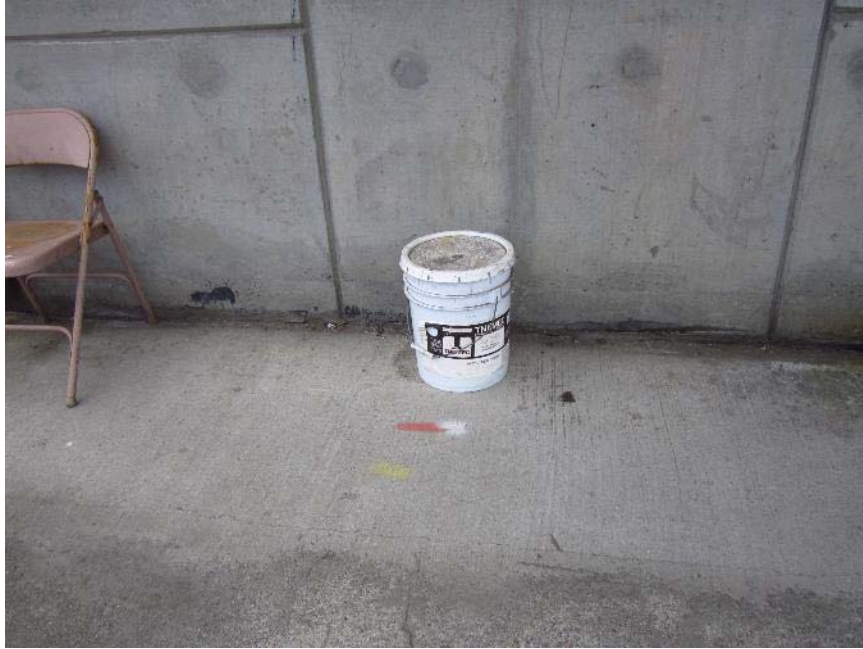
Photograph 19. Seattle City Light South Service Center – View of TNEC Series 156 Enviro-crete, a modified waterborne acrylate stored outside without secondary containment at the central-west area of the property.

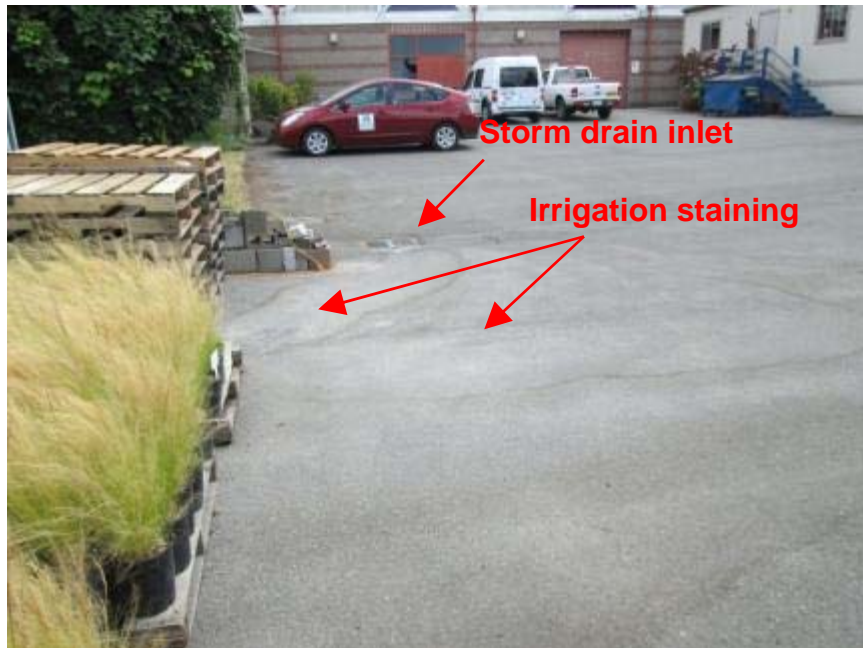
Photograph 20. Jefferson Park Horticulture Center – View facing east of staining from irrigation water flowing into the storm drain inlet at the central area of the property.

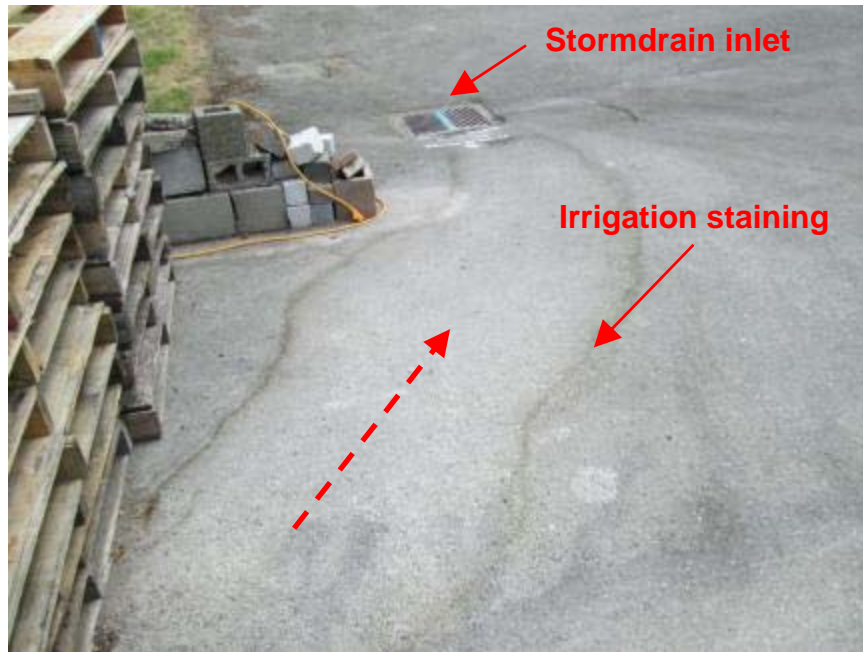
Photograph 21. Jefferson Park Horticulture Center – Closeup view of staining on pavement showing irrigation water flowing to storm drain inlet in the central area of the property.

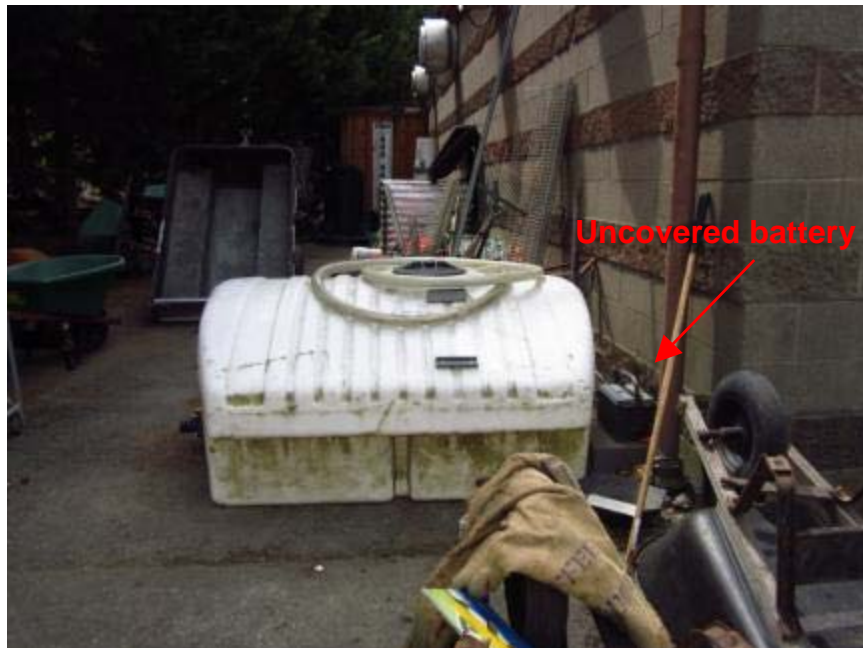
Photograph 22. Jefferson Park Horticulture Center – View facing south of an uncovered battery stored behind a storage building in the southeast corner of the site.
